Date: July 20, 2022

Subject: 301 Mission Retrofit Supplemental Monitoring Report 063S: Results as of July 19, 2022

Millennium Tower Perimeter Pile Upgrade: Instrumentation Monitoring Data
City and County of San Francisco, California

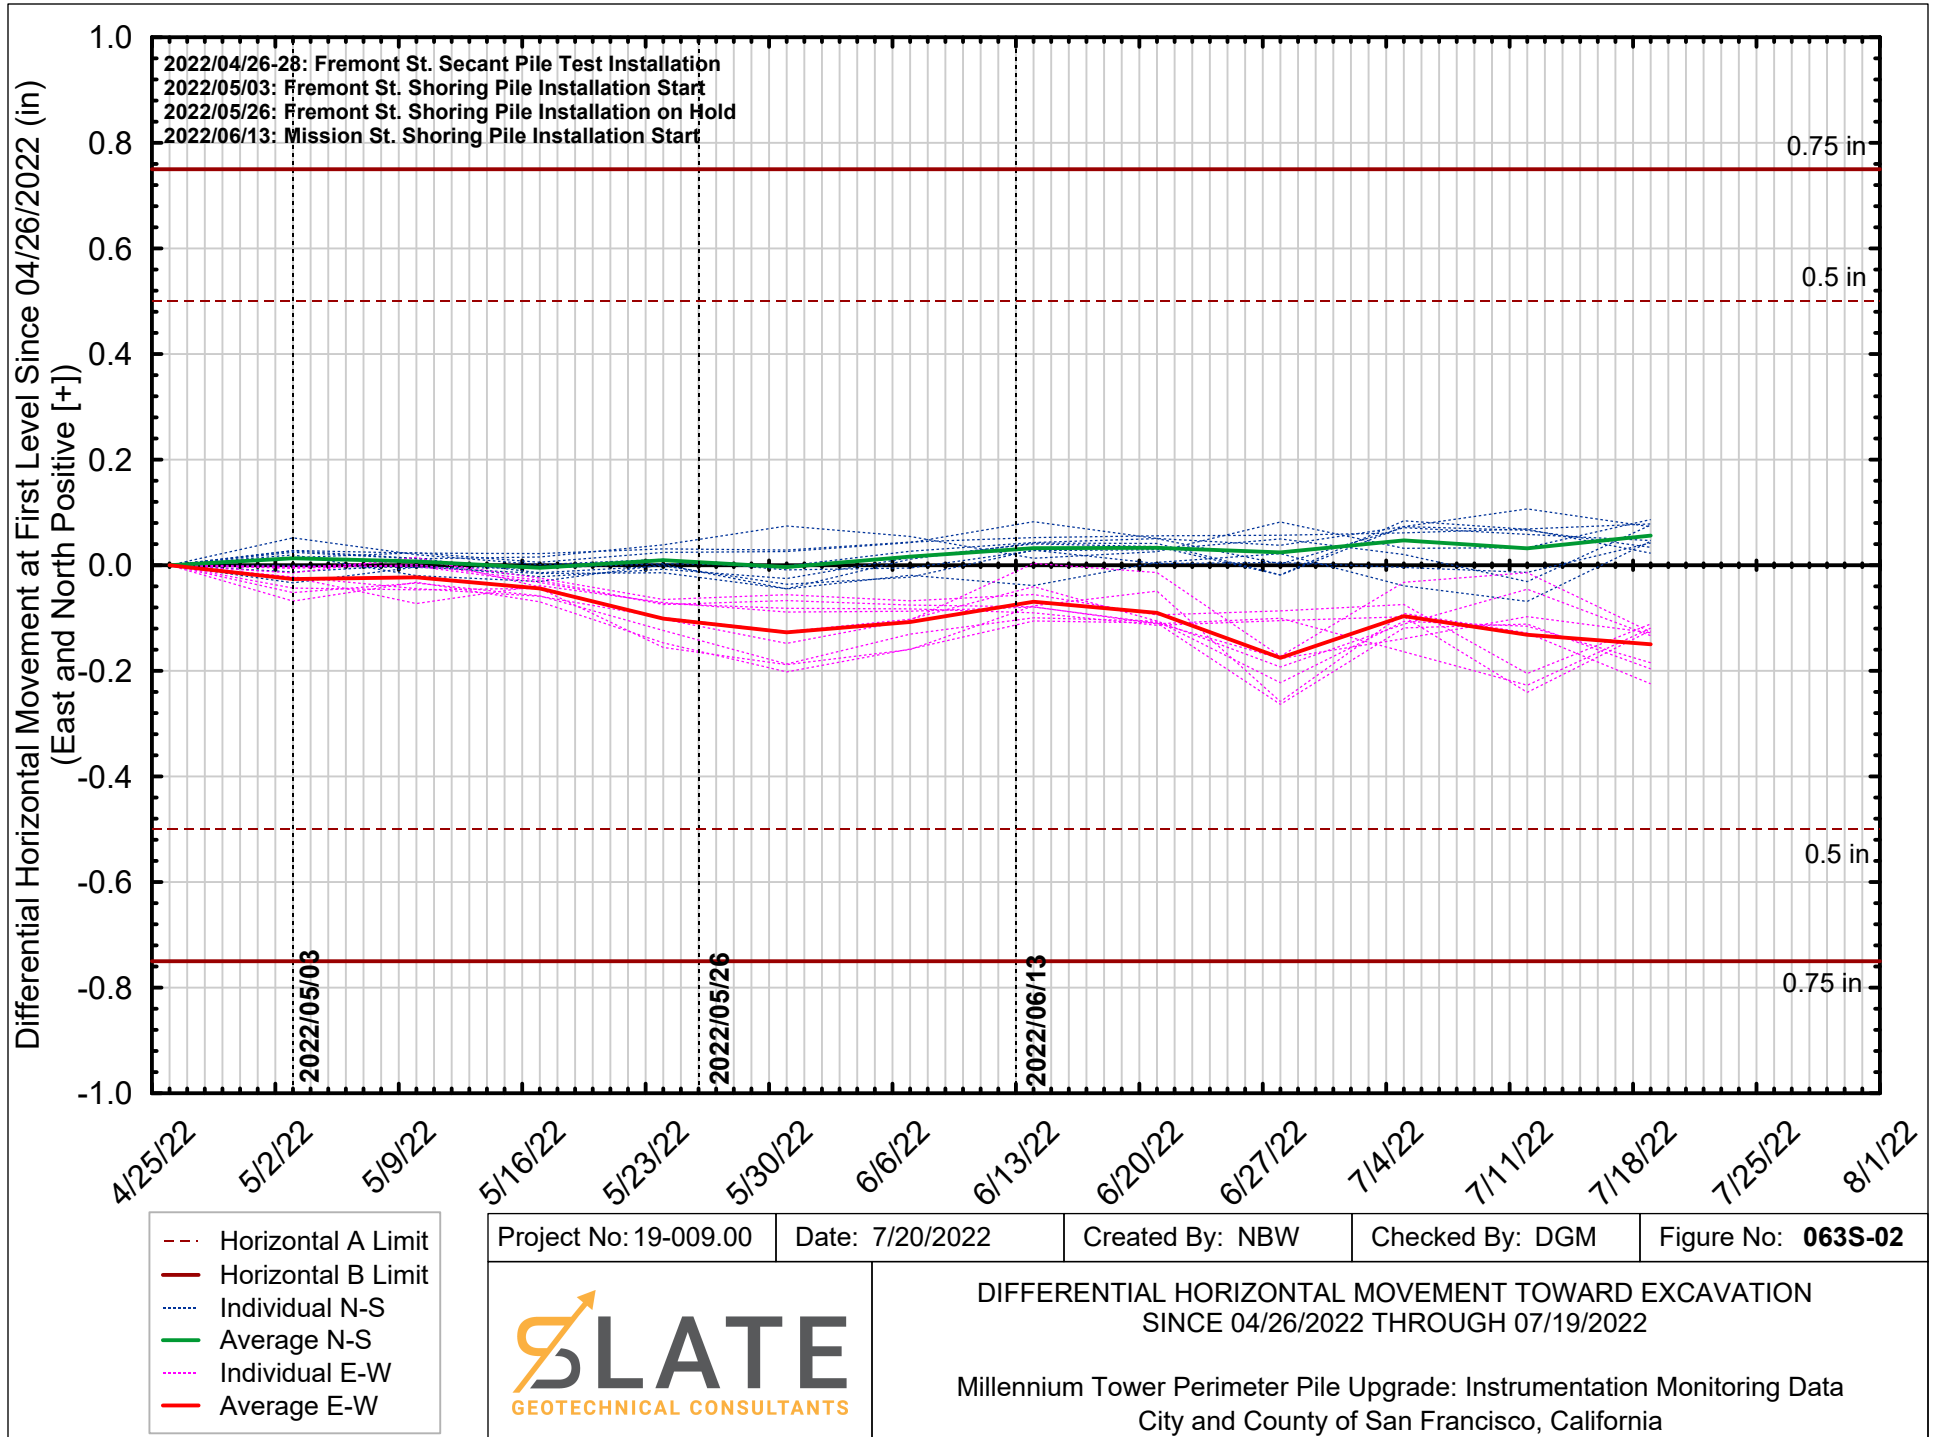
Figure S-02 – Differential Horizontal Movement Toward Excavation Since 04/26/2022 through 07/19/2022

Figure S-02 presents the differential horizontal movement toward the excavation at survey prisms installed at approximately one floor level above grade on the exterior of the building, as well as the average in each of the project north-south and east-west direction, since April 26, 2022, through July 19, 2022. Limits established in the aforementioned letter are included for reference.

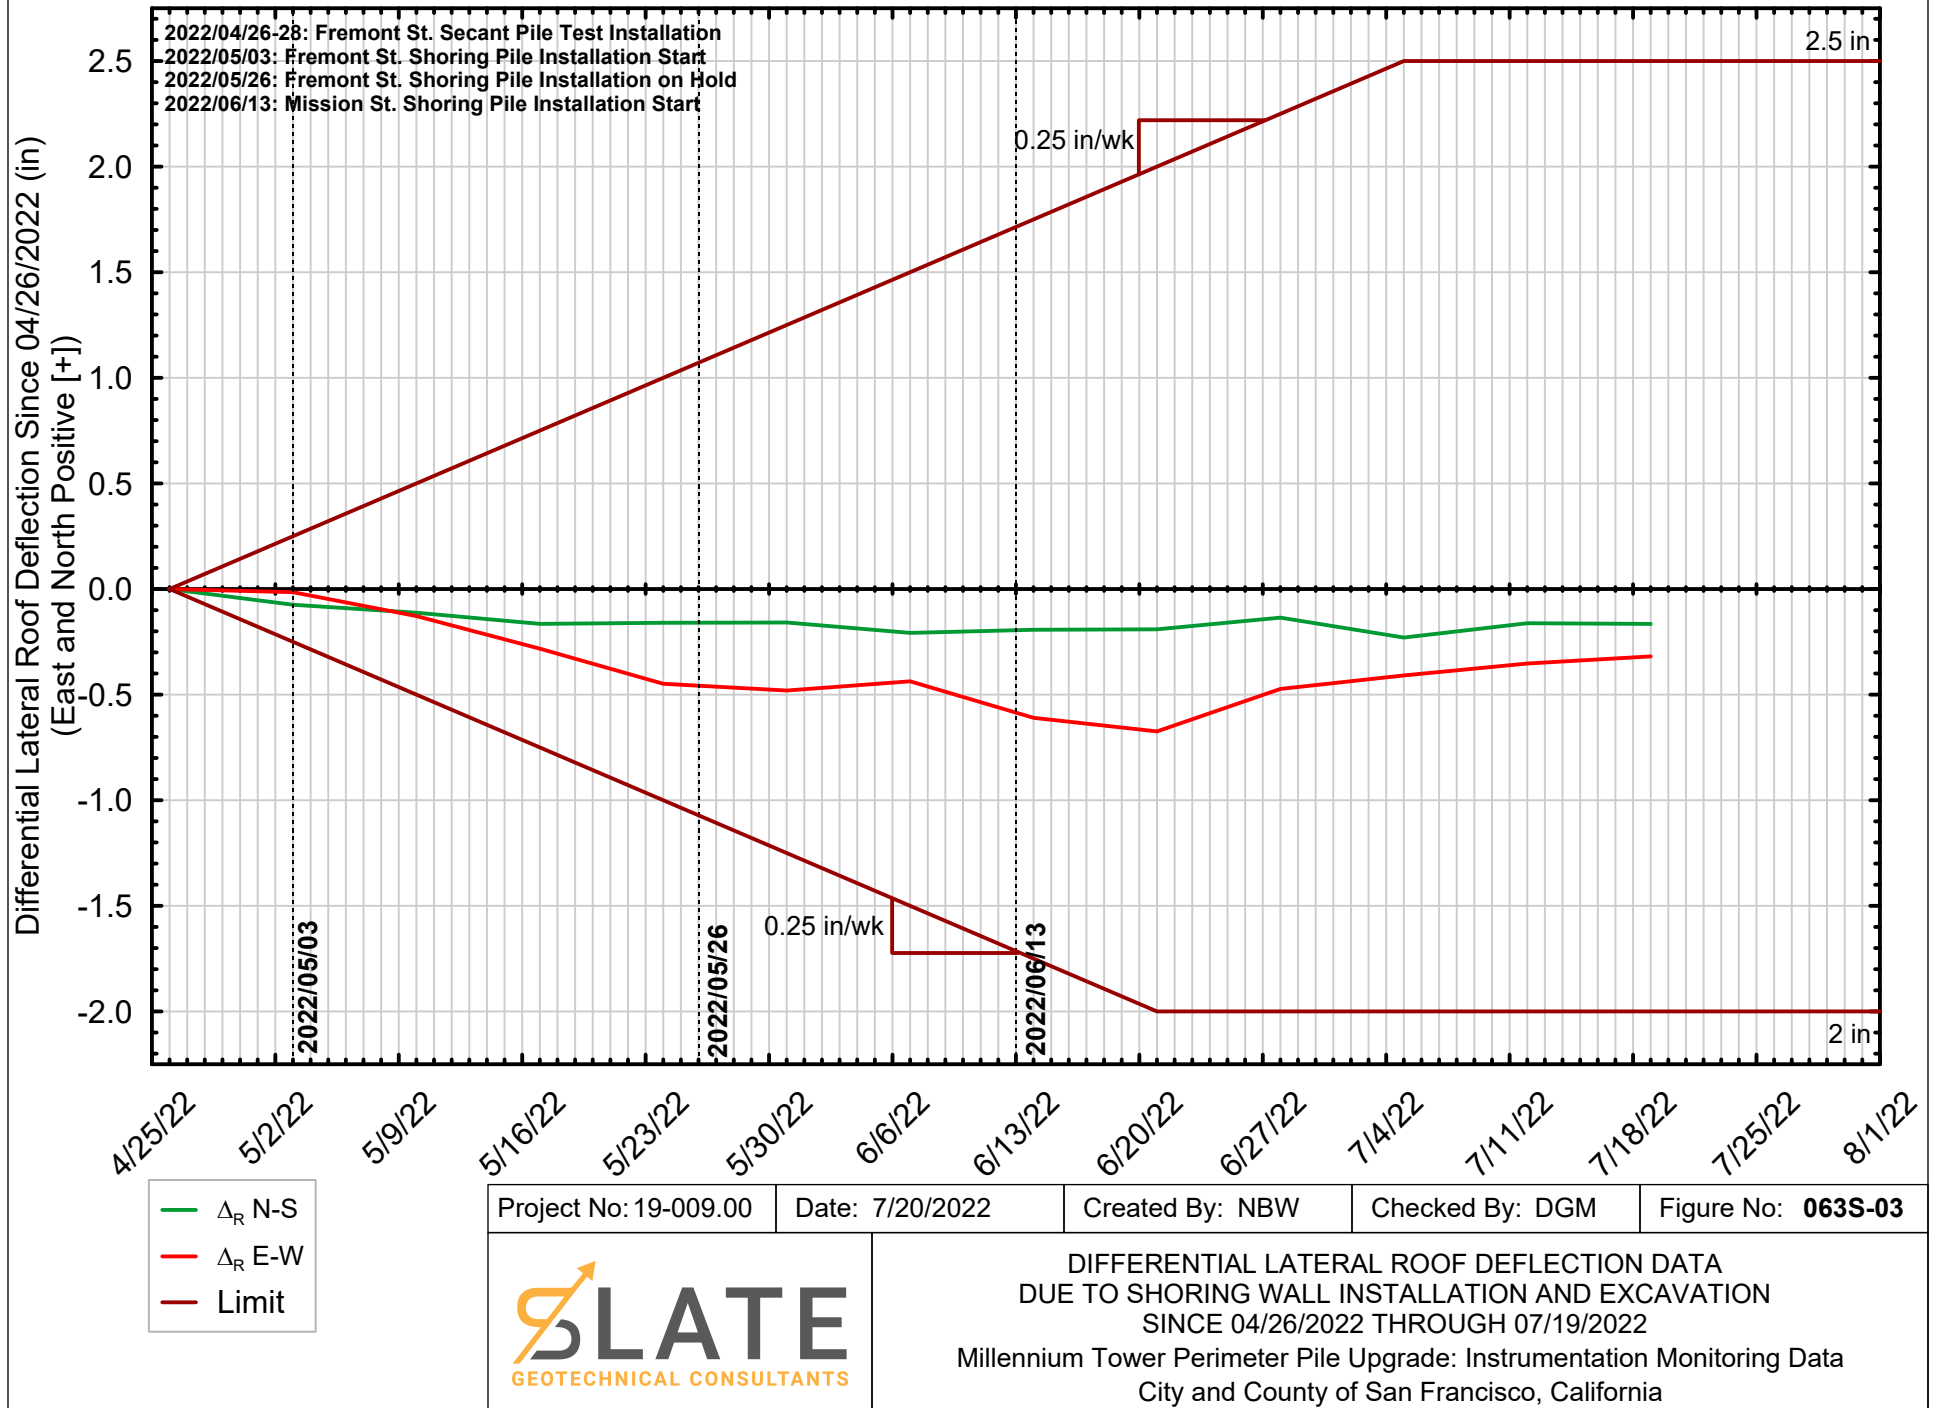
Figure S-03 – Differential Lateral Roof Deflection Data due to Shoring Wall Installation and Excavation since 04/26/2022 through 07/19/2022

Figure S-03 presents differential lateral roof deflection data due to shoring wall installation and excavation since April 26, 2022, through July 19, 2022. Limits established in the aforementioned letter are included for reference. Note that differential lateral roof deflection due to shoring wall installation and excavation is calculated following the aforementioned letter as:

$$\Delta_R = \Delta_{R-prism} - \Delta_H - \alpha T$$

where: Δ_R is the computed differential lateral roof deflection due to shoring wall installation and excavation;
 $\Delta_{R-prism}$ is the differential lateral roof deflection obtained from prism data;
 Δ_H is the average differential horizontal movement "at-grade";
 α is the weekly lateral roof deflection rate (computed as described below); and,
 T is the number of weeks since initiation of shoring wall installation or excavation.

The time frame over which α is computed changes depending on the phase of the work, as specified in the aforementioned letter. For the construction phase during which the shoring wall is installed (currently

ongoing), α is computed from the two months of monitoring conducted immediately prior to the shoring wall installation (i.e., monitoring data from February 22, 2022, through April 25, 2022). During the excavation phase (to occur in the future), α will be readjusted to reflect the recorded lateral roof deflection rate in the two months immediately preceding the start of excavation (dates to be determined).

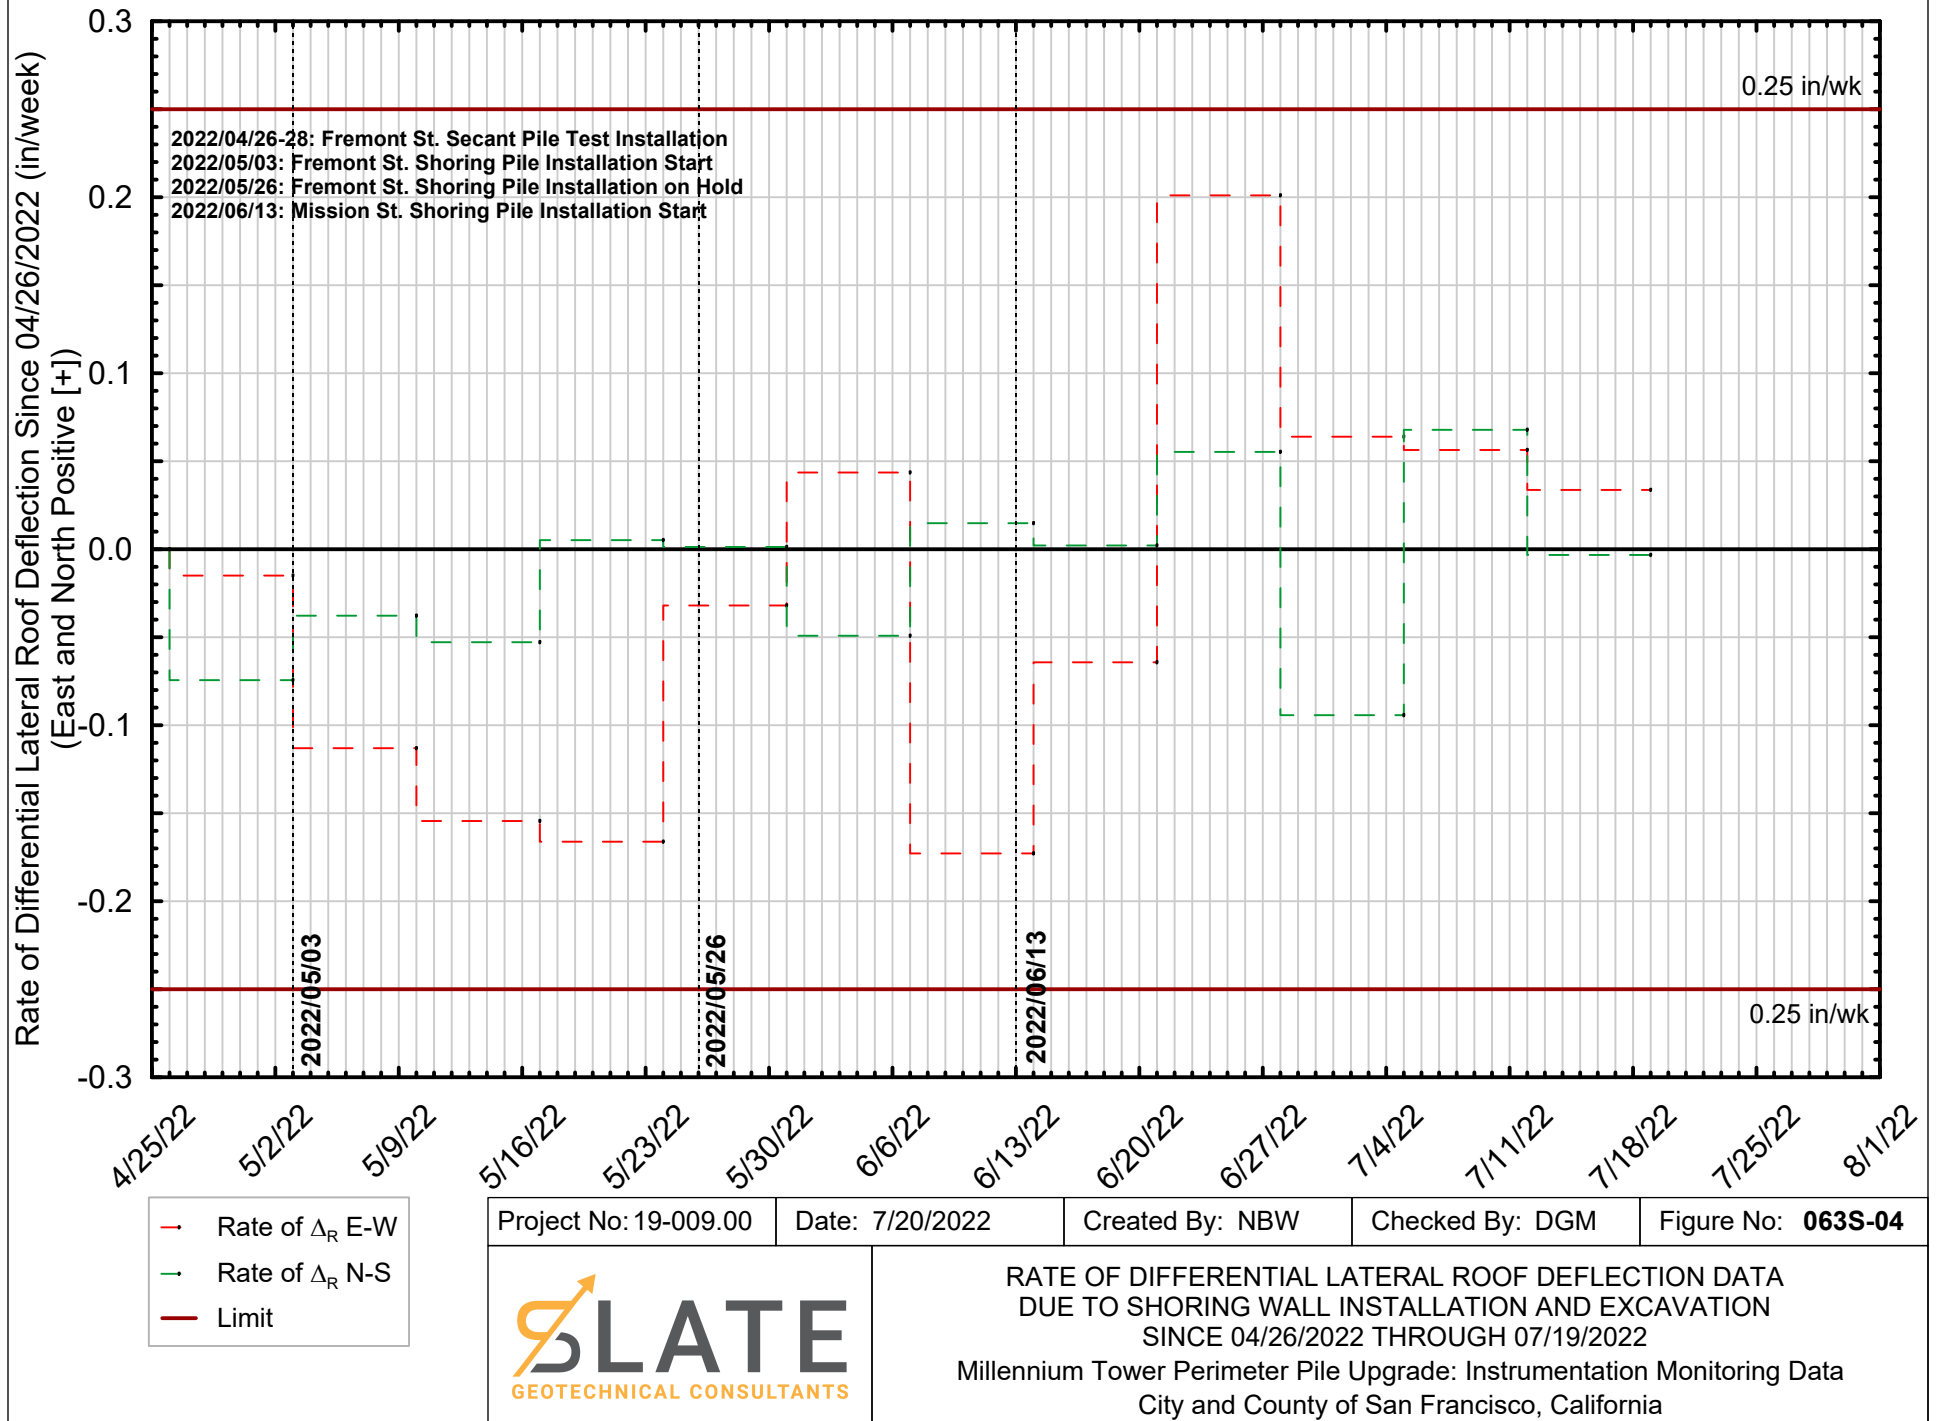
Figure S-04 – Rate of Differential Lateral Roof Deflection Data due to Shoring Wall Installation and Excavation since 04/26/2022 through 07/19/2022

Figure S-04 presents rates of differential lateral roof deflection data due to shoring wall installation and excavation since April 26, 2022, through July 19, 2022. Limits established in the aforementioned letter are included for reference. Note that the rates are calculated as:

$$\frac{d\Delta_R}{dT} \approx \frac{\Delta_{R,t} - \Delta_{R,t-1}}{T_t - T_{t-1}}$$

where: t is an index representing the current instance in time; and
 $t - 1$ is an index representing the previous instance in time.
